Manhole Inspection Summary

Manhole # S05UU1003MH

Insp Date: **9/26/06 1:37 PM**

Location Address: **3416 TRAINOR AVE**

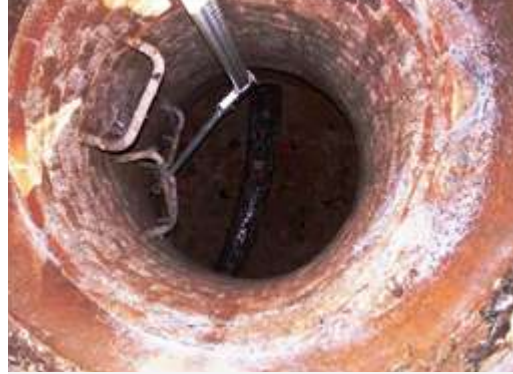
Top View

Adjustment deterioration and infiltration. Corbel and Barrel infiltration. Evidence of surcharge - Bench debris. Corroded

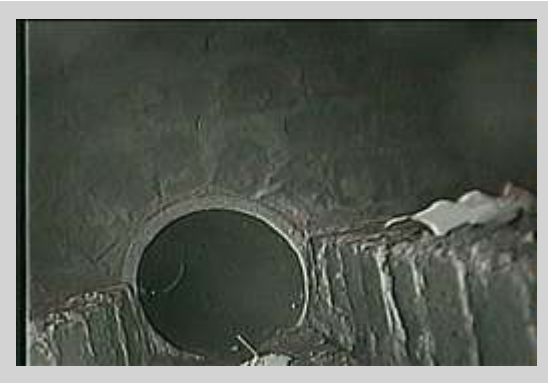
8 in. Circular Gravity Sewer Pipe Out @ 12 O'Clock

Channel deterioration.

Infiltration: **None** Pipe Seal Cond: **Unknown**

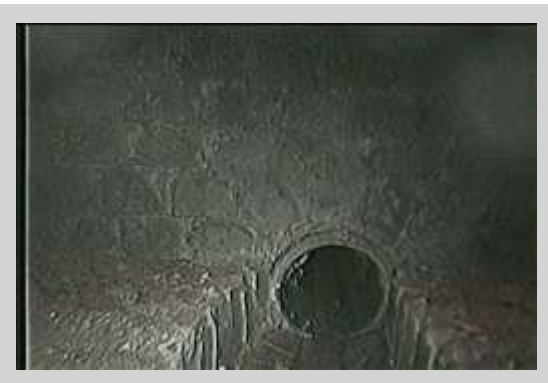
6 in. Circular Gravity Sewer Pipe In @ 7 O'Clock

Barrel deterioration and infiltration.

Infiltration: **Evidence** Pipe Seal Cond: **Cracked**
